COLORADO DEPARTMENT OF PUBLIC HEALTH
AND ENVIRONMENT

SITE INSPECTION

ANALYTICAL RESULTS REPORT

UPPER ANIMAS WATERSHED (CERCLIS ID # CO0001411347)

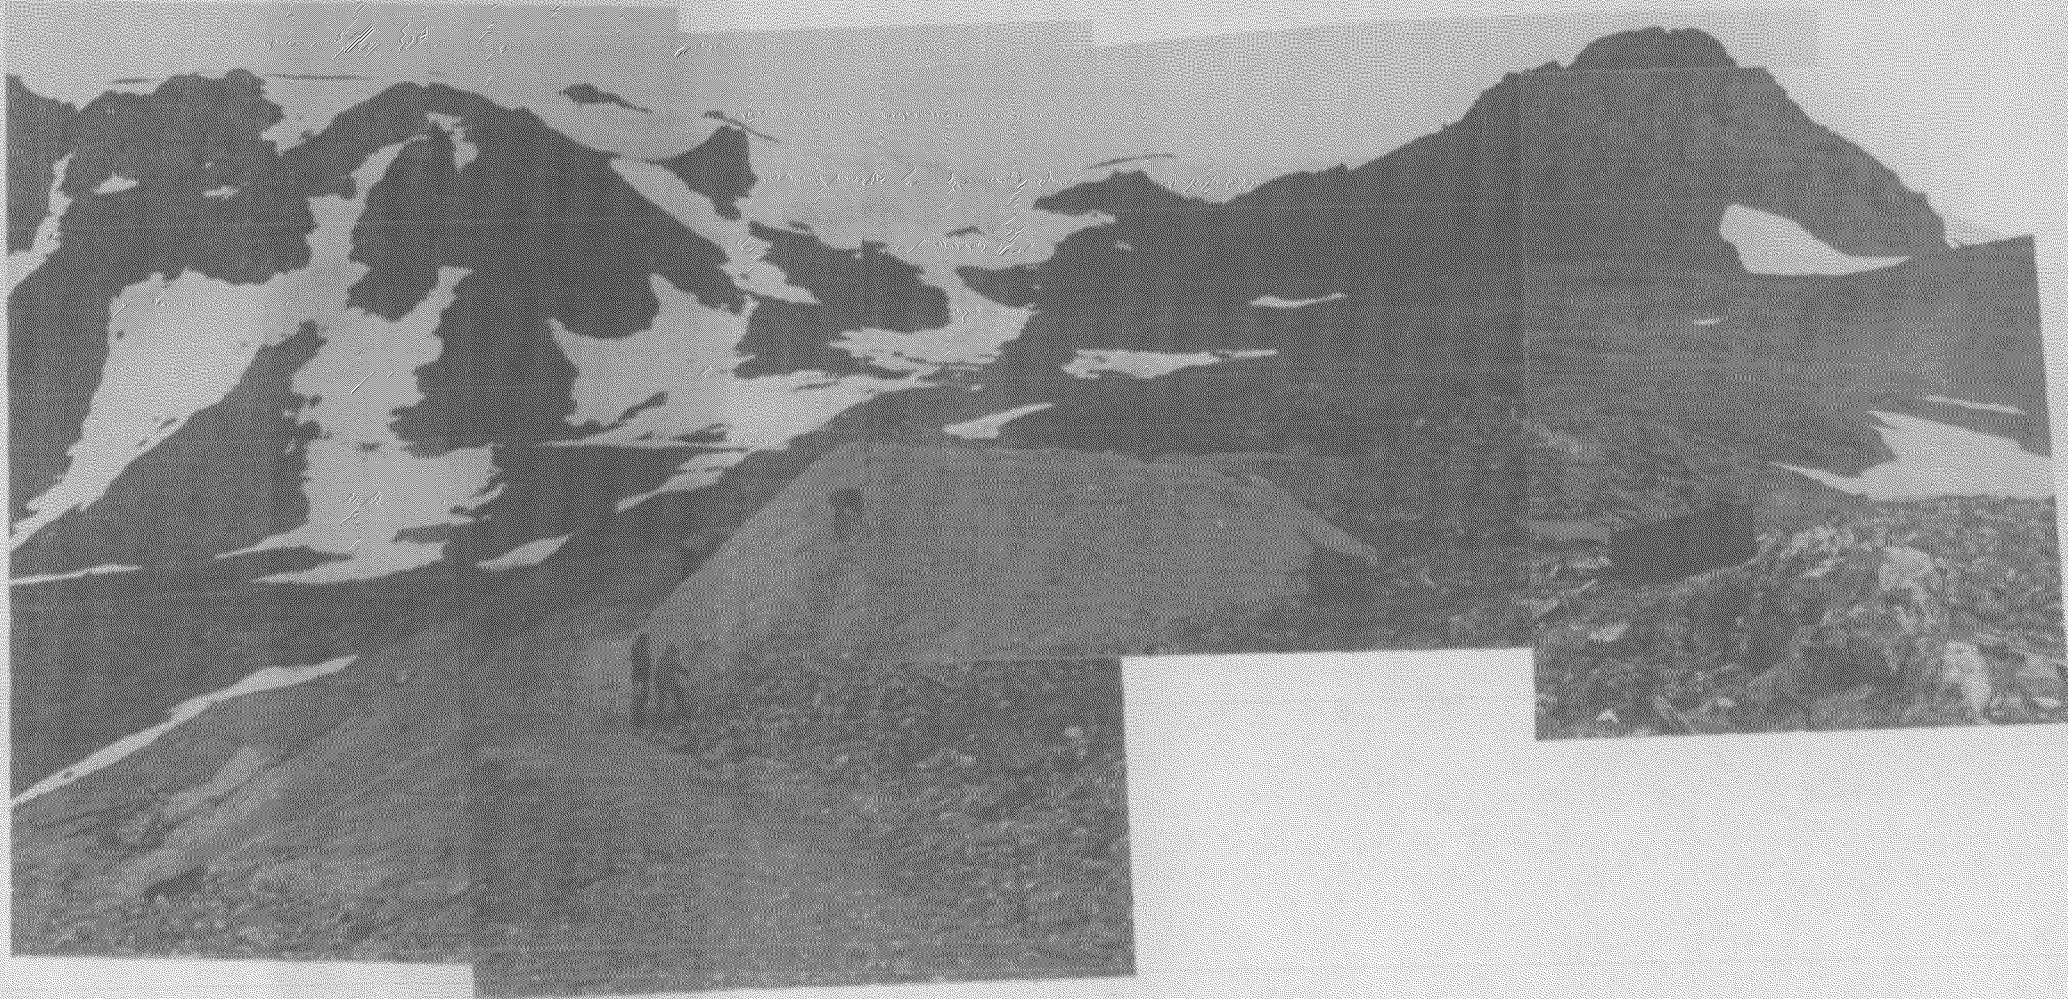
Description of Photo: 50-1 Upper Mountain Queen Waste Pile

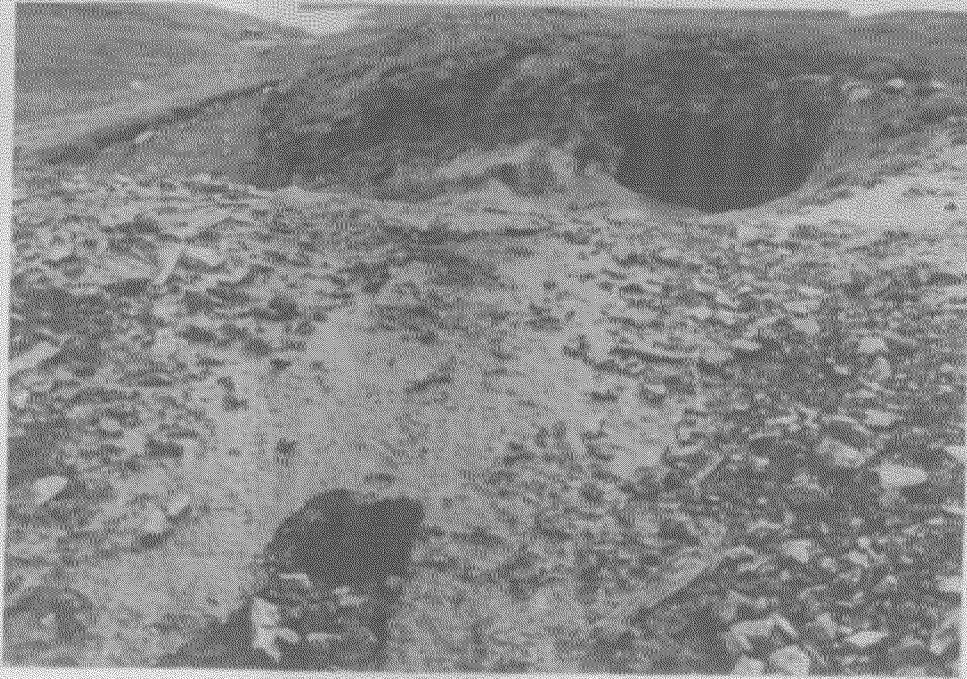
Description of Photo: SO-2 Portal and Mine drainage (note fencecrete).

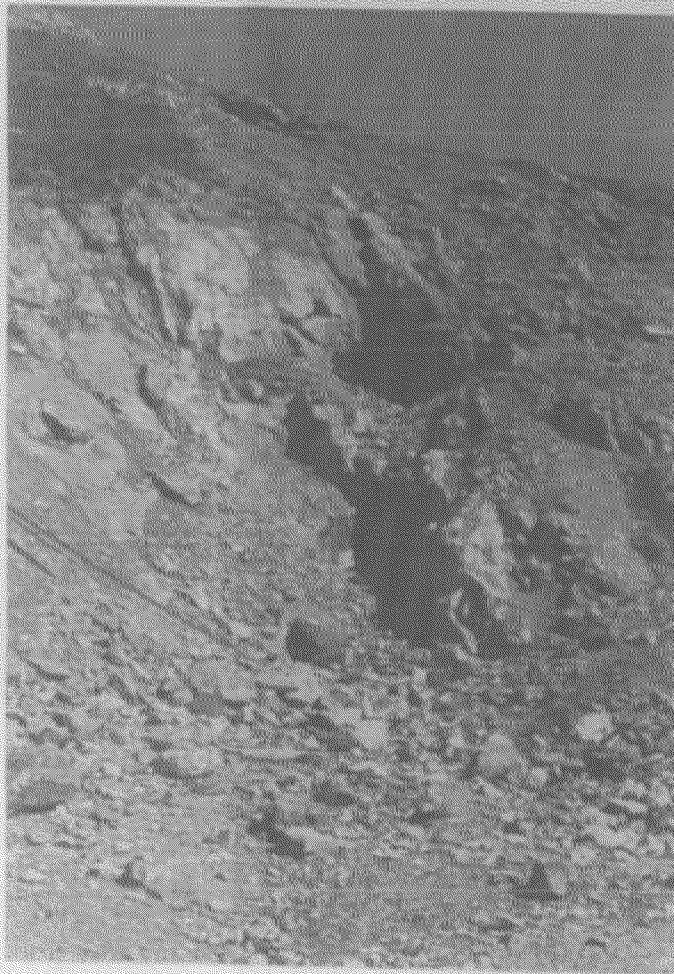
Description of Photo: SO-4 Portal.
Date: August 12, 1997 Time: 1000
Direction facing: North (35mm film)

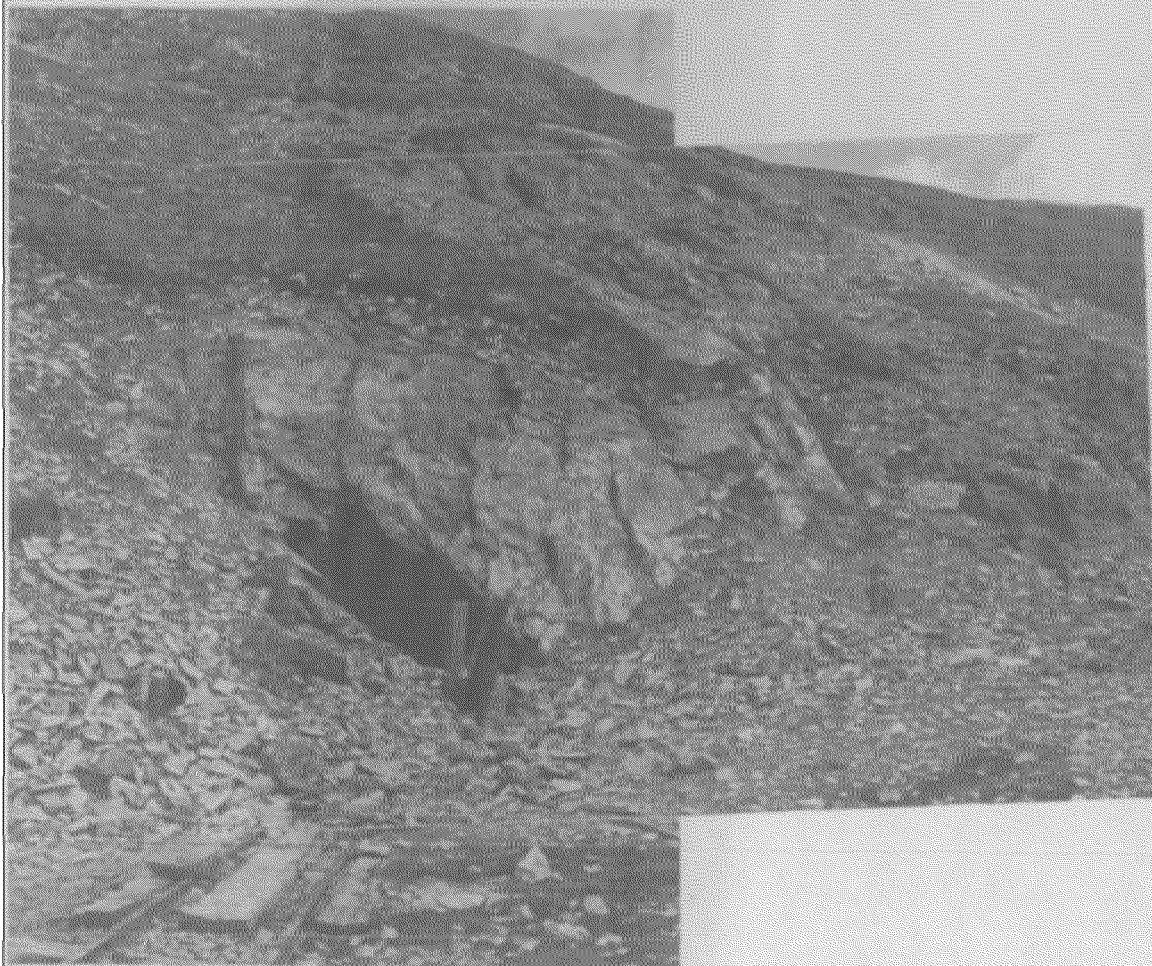
Description of Photo: SO-5 Mine Portal
Date: August 12, 1997 Time: 1115
Direction facing: North (35mm film)

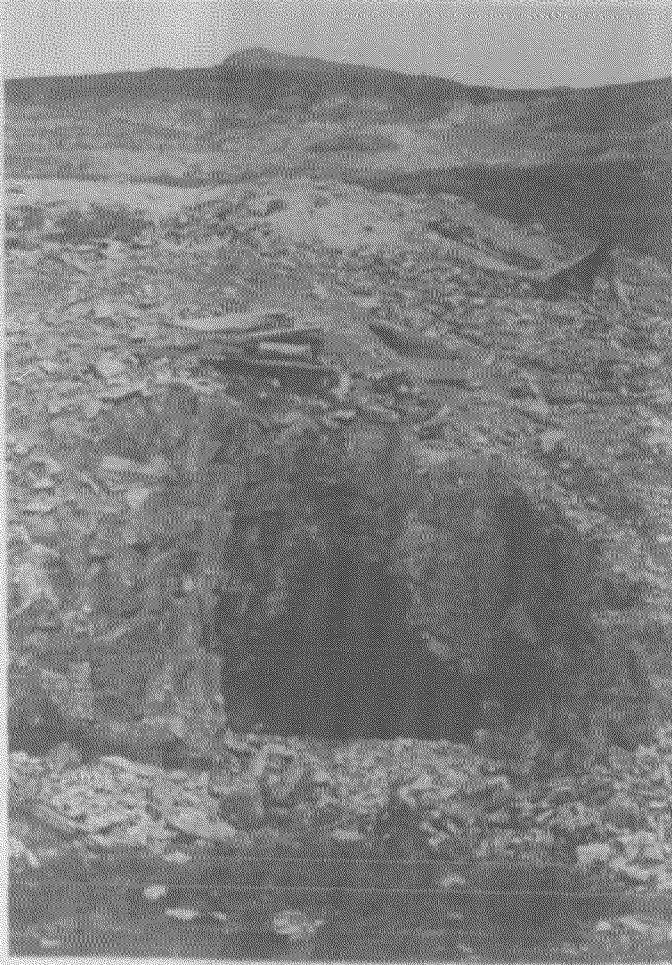
Description of Photo: SO-7 Mine Portal
Date: August 12, 1997 Time: 1130
Direction facing: North (35mm film)

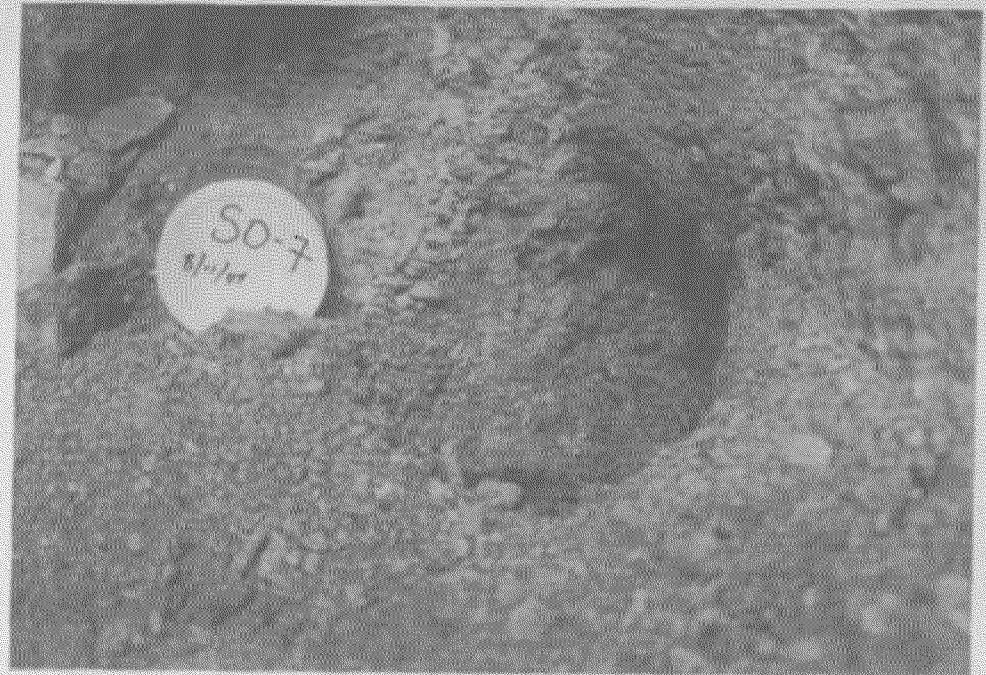
Description of Photo: SO-7 Mine Waste sample
Date: August 12, 1997 Time: 1130
Direction facing: North (35mm film)

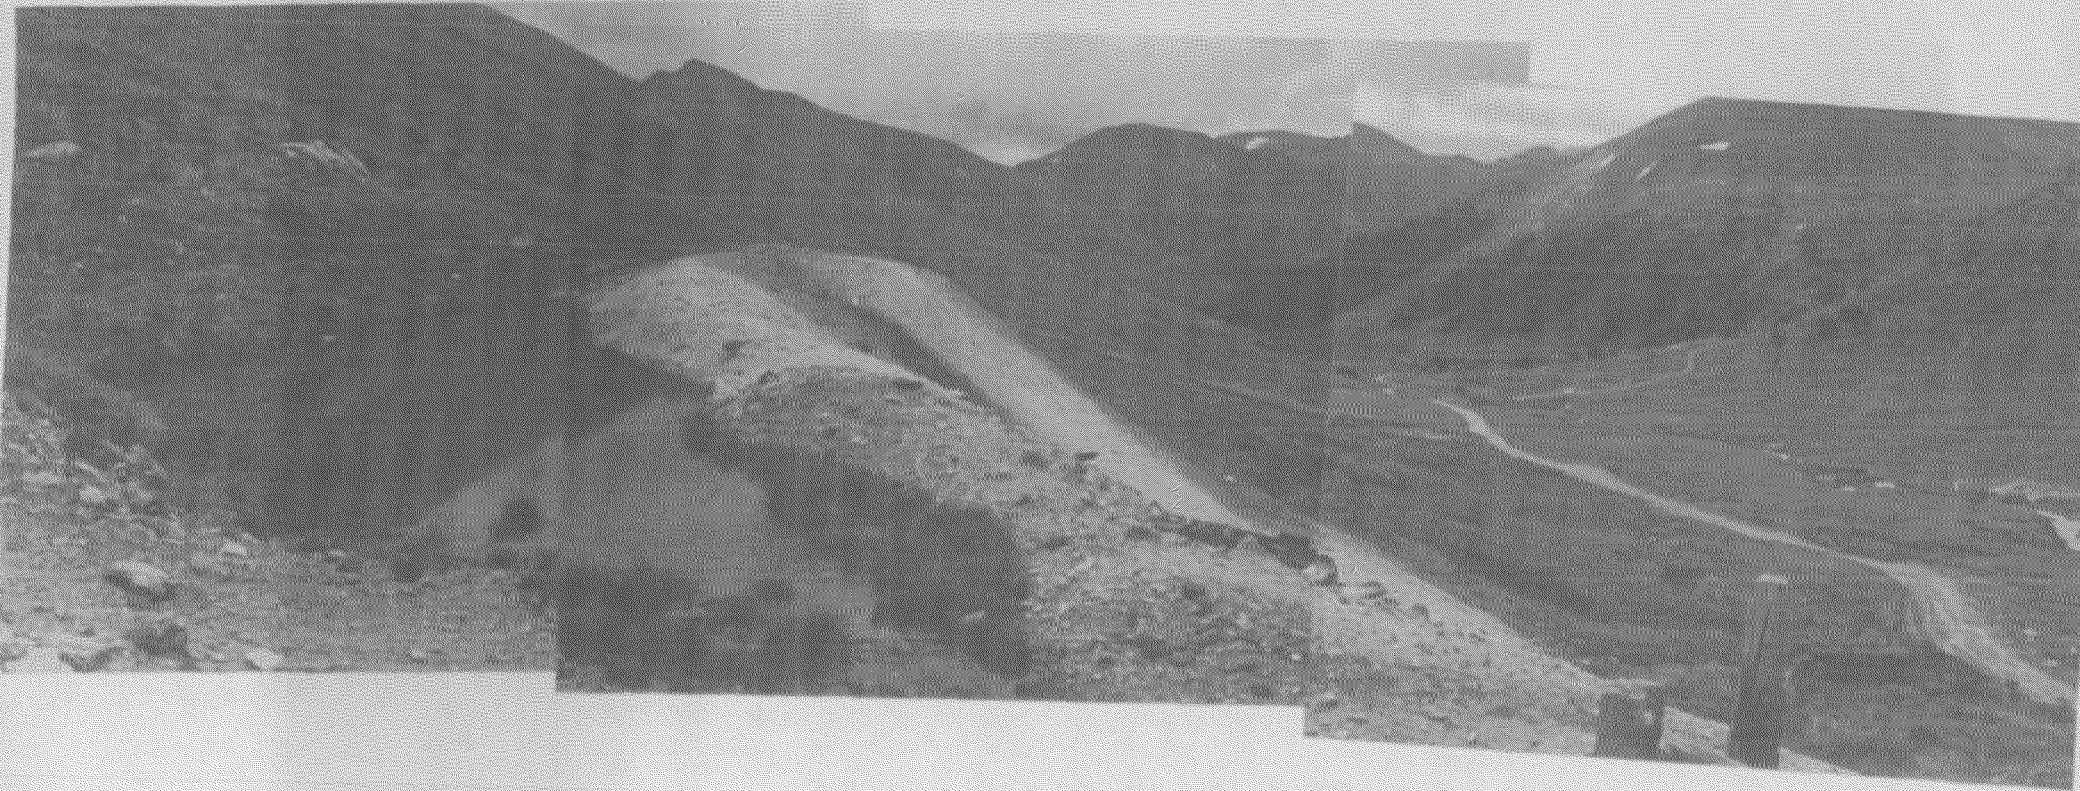
Description of Photo: SO-G Mine waste pile.
Date: August 11, 1997
Direction facing: Southeast (35mm film)

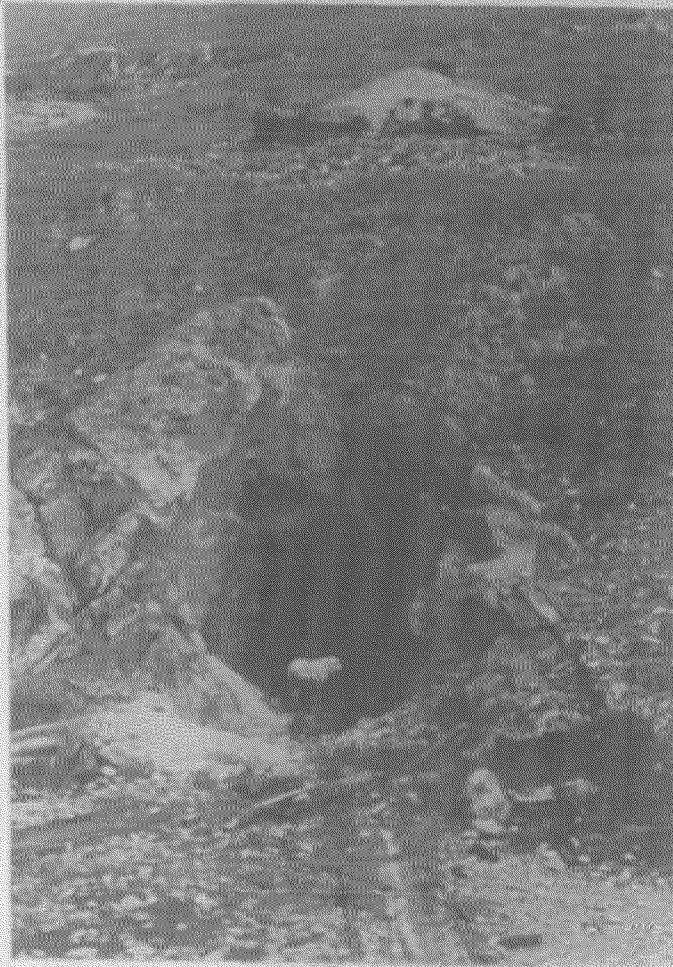
Description of Photo: SO-8 Mine Portal
Date: August 11, 1997 Time: 1130
Direction facing: North (35mm film)

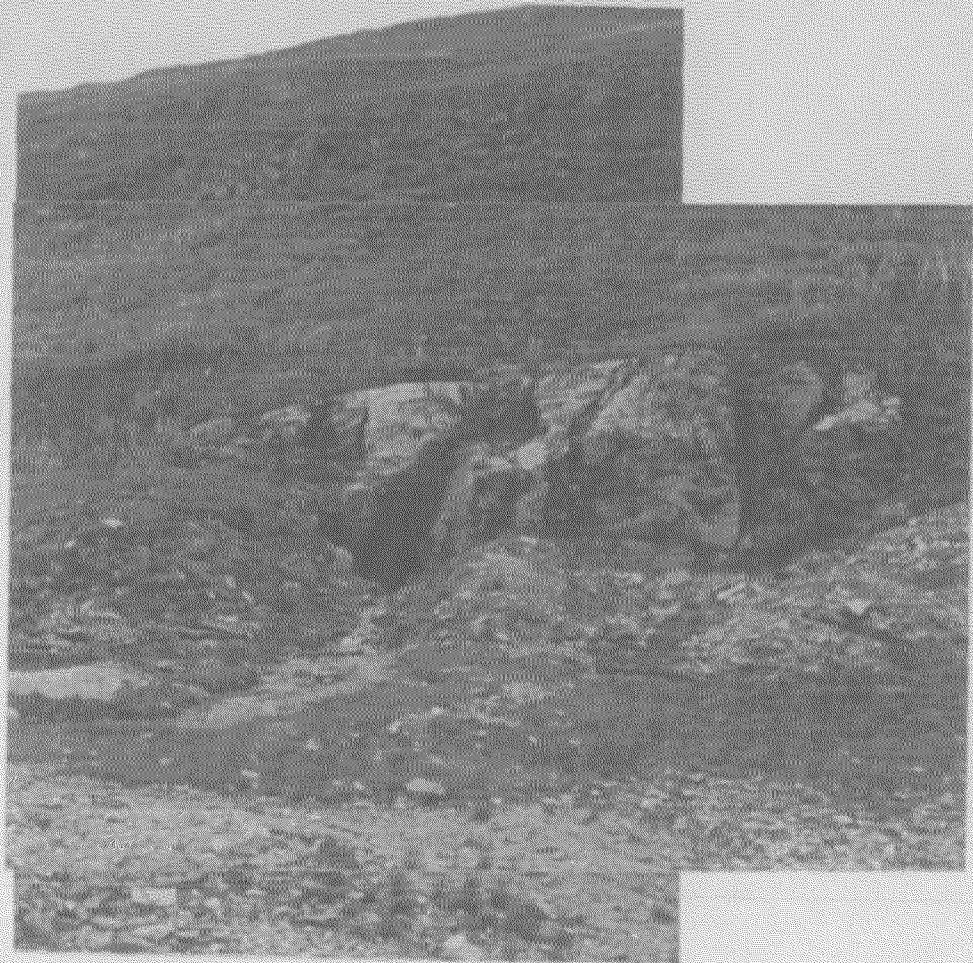
Description of Photo: SO-9 Mine Portal
Date: August 11, 1997
Direction facing: North (35mm film)

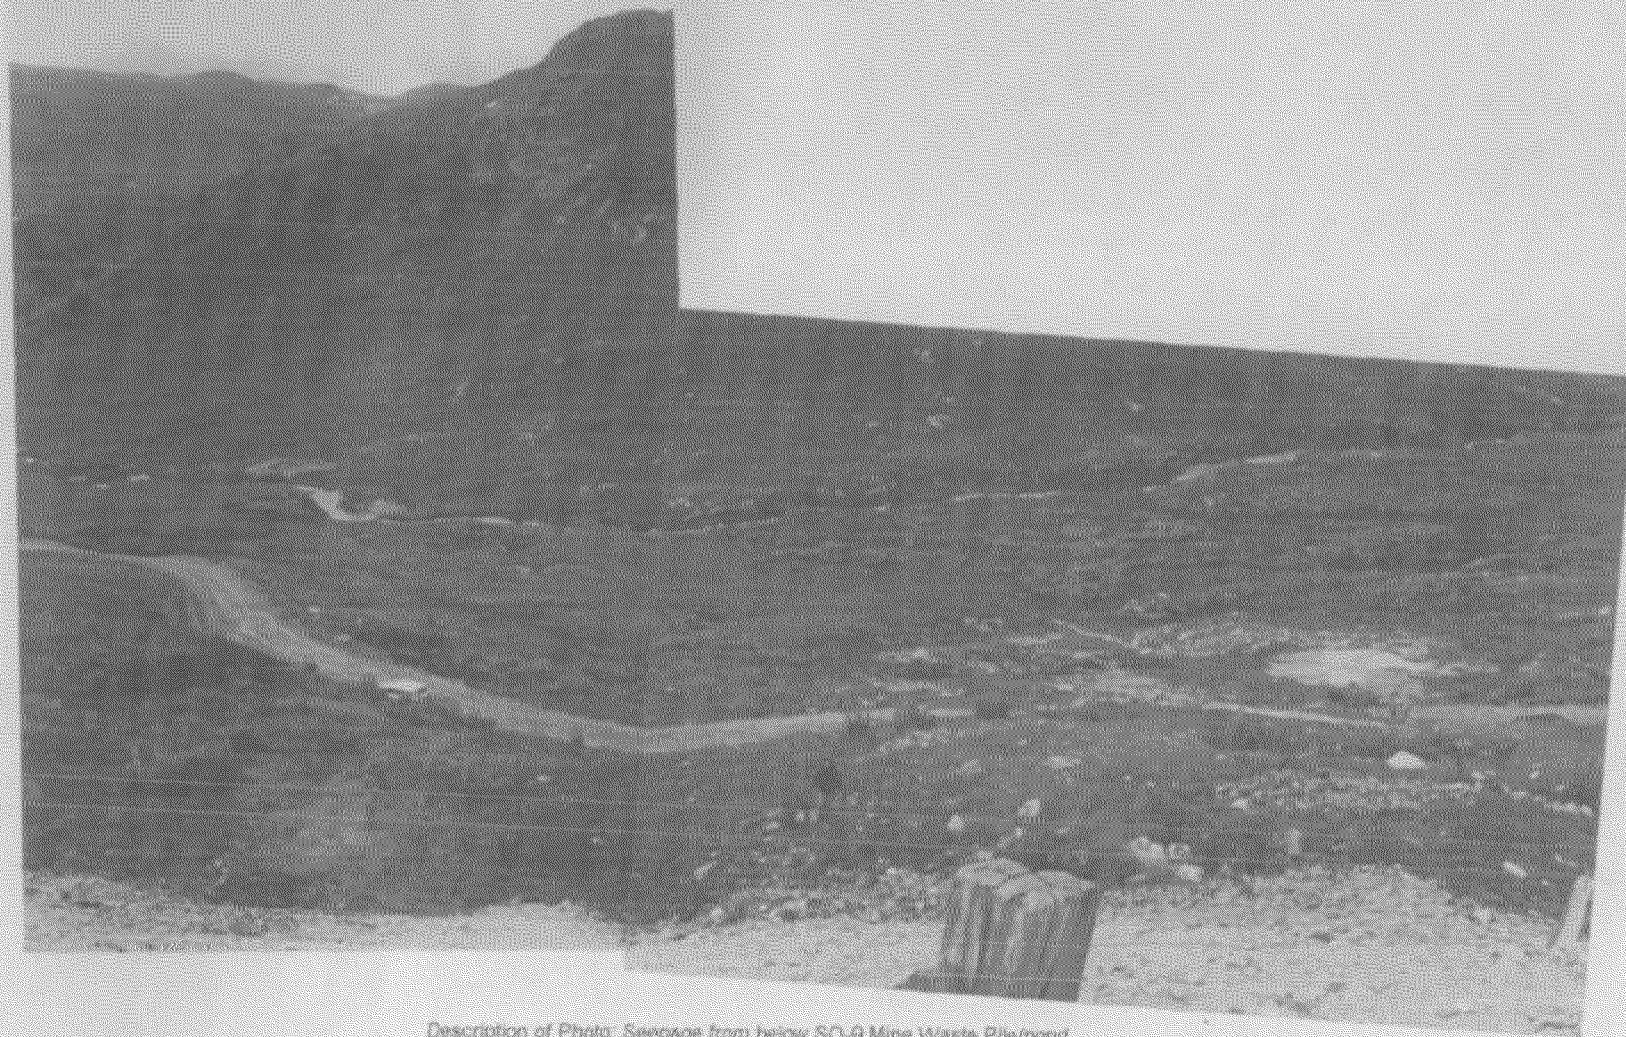
Description of Photo: Seepage from below SO-G Mine Waste Pile/pond
Date: August 11, 1997 Time: 1200
Direction facing: Southeast (35mm film)

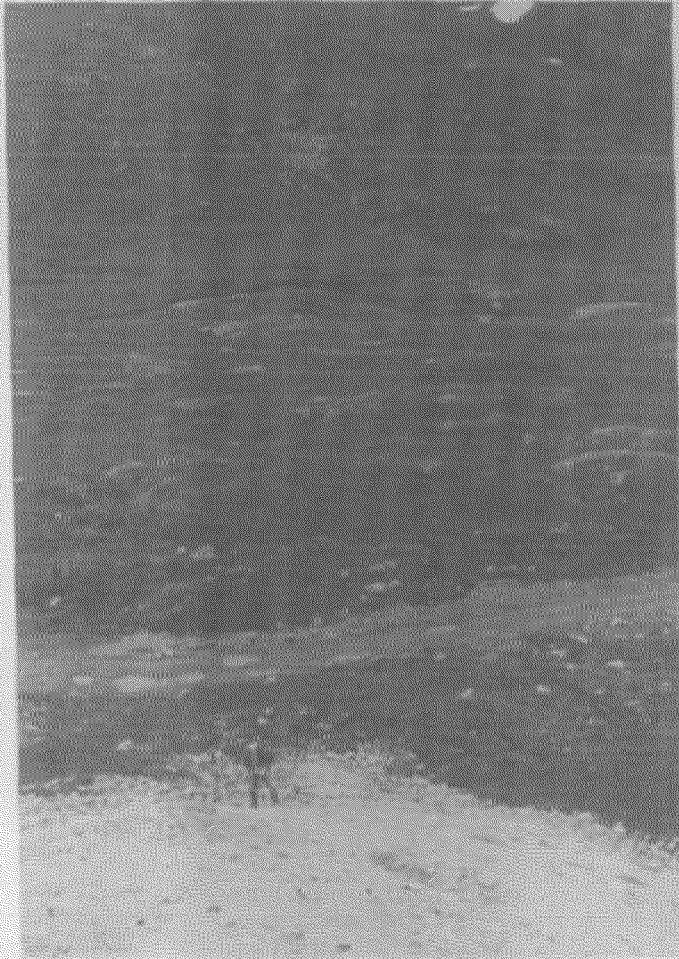
Description of Photo: SO-8 Mine Waste Pile.
Date: August 11, 1997 Time: 11:45
Direction facing: South (35mm film)

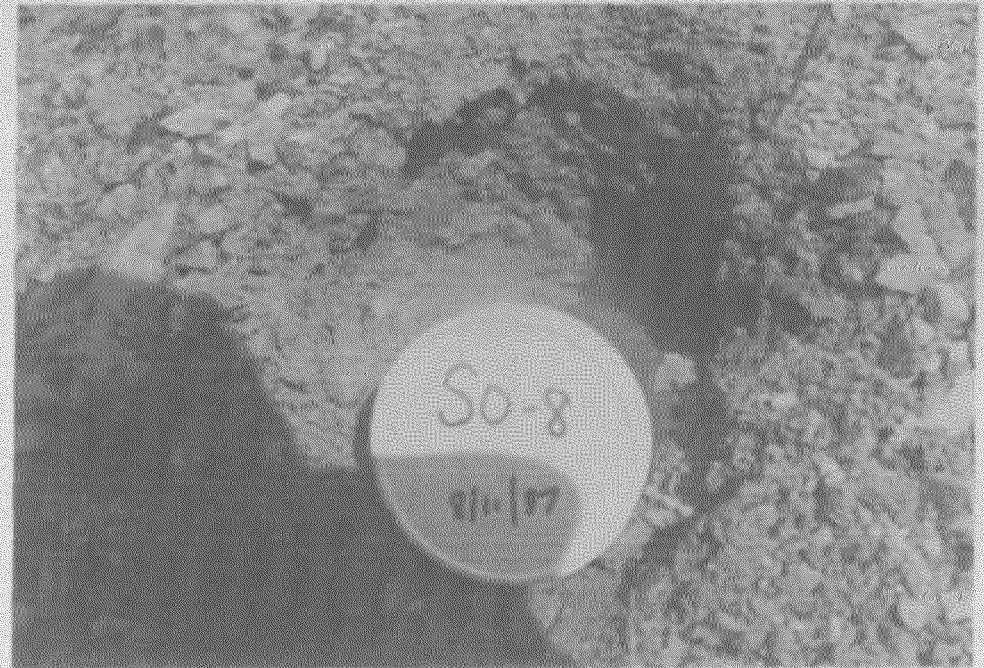
Description of Photo: SO-8 Mine waste sample.
Date: August 11, 1997 Time: 11:45
Direction facing: South (35mm film)

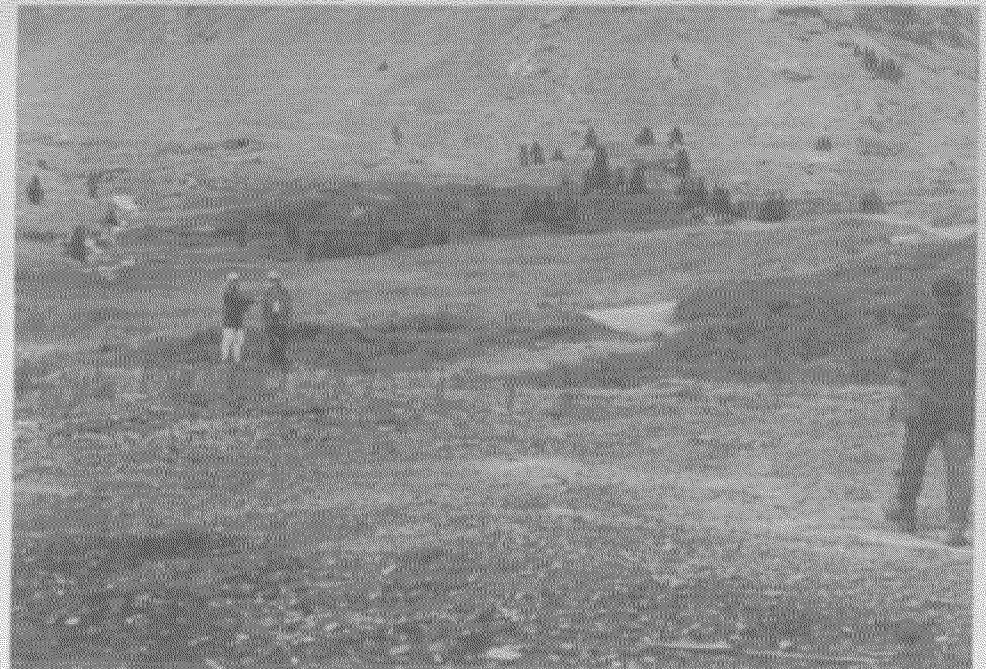
Description of Photo: SO-10 Bagley Tunnel Mine Dump
Date: August 11, 1997
Direction facing: South (35mm film)

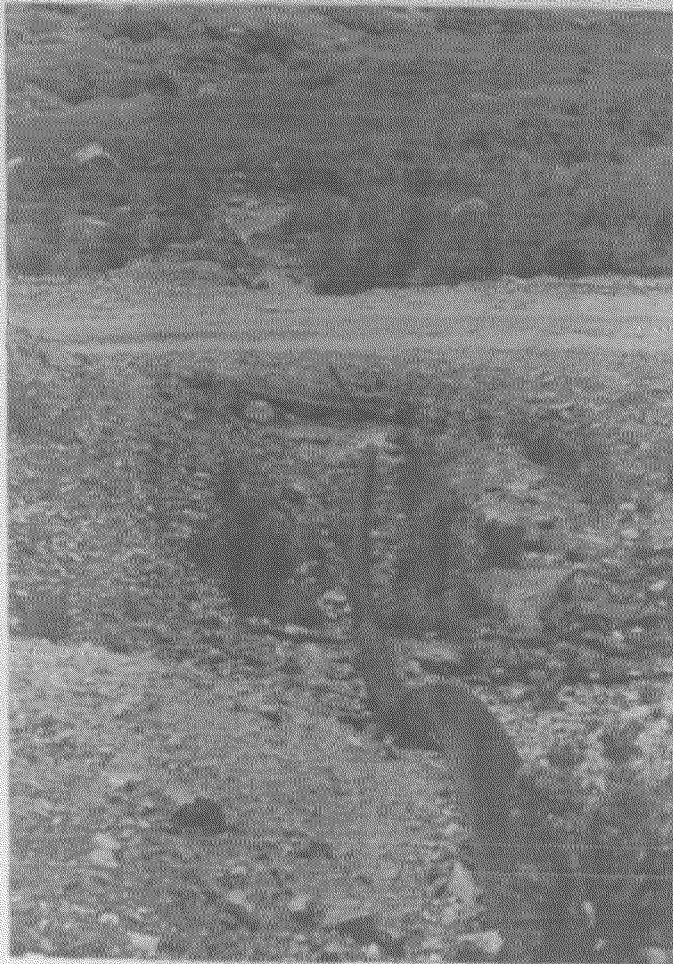
Description of Photo: SO-10 Bagley Tunnel Portal Mine Drainage (DM-19).

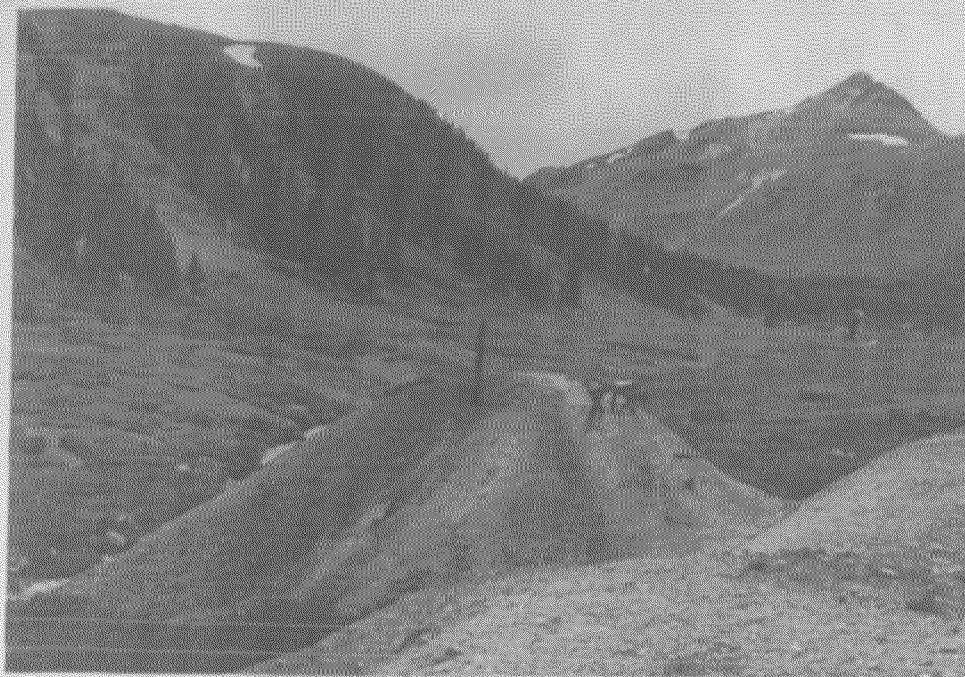
Description of Photo: SO-10 Looking west at Bagley T. Waste Pile.
Date: August 11, 1997 Time: 1315
Direction facing: West (35mm film)

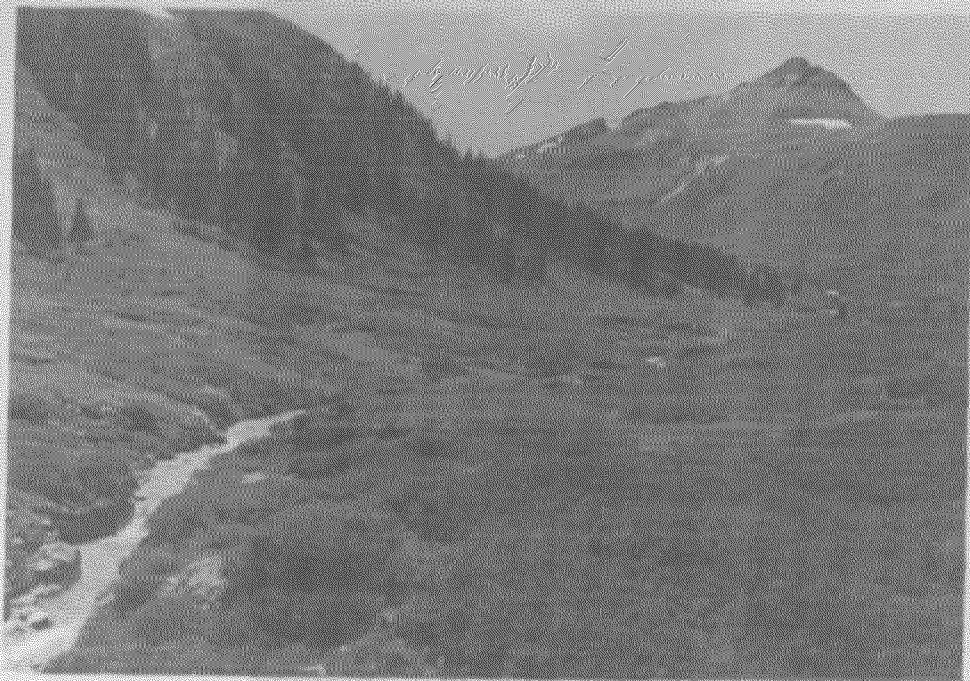
Description of Photo: SO-10 Looking west of Bagley T. Waste Pile.
Date: August 11, 1997 Time: 1315
Direction facing: West (35mm film)

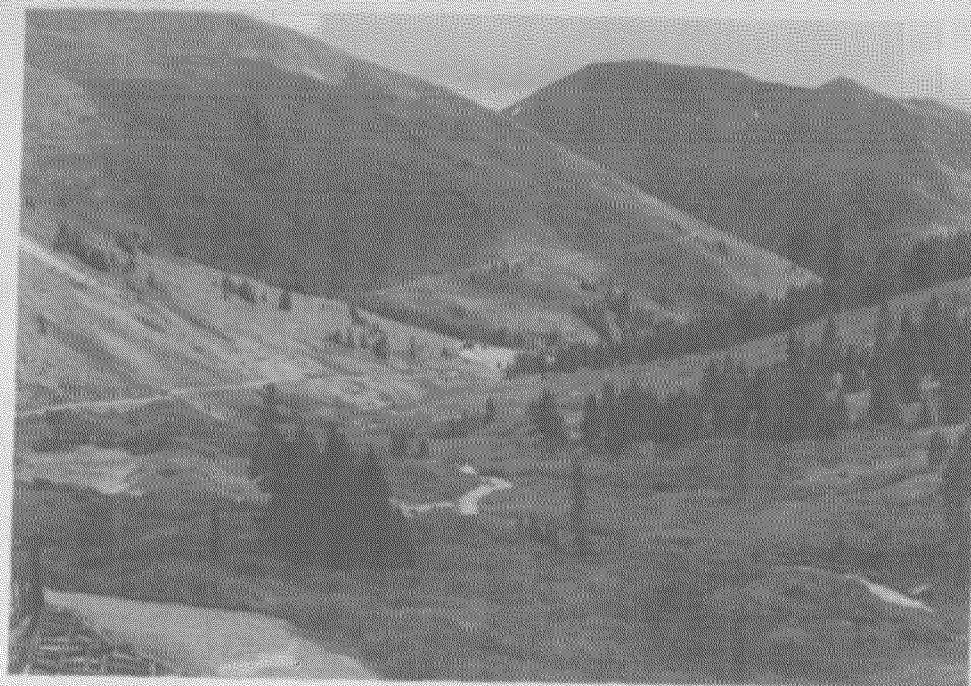
Description of Photo: SO-10 Looking east of Bagley T. Waste Pile.
Date: August 11, 1997 Time: 1315
Direction facing: East (35mm film)

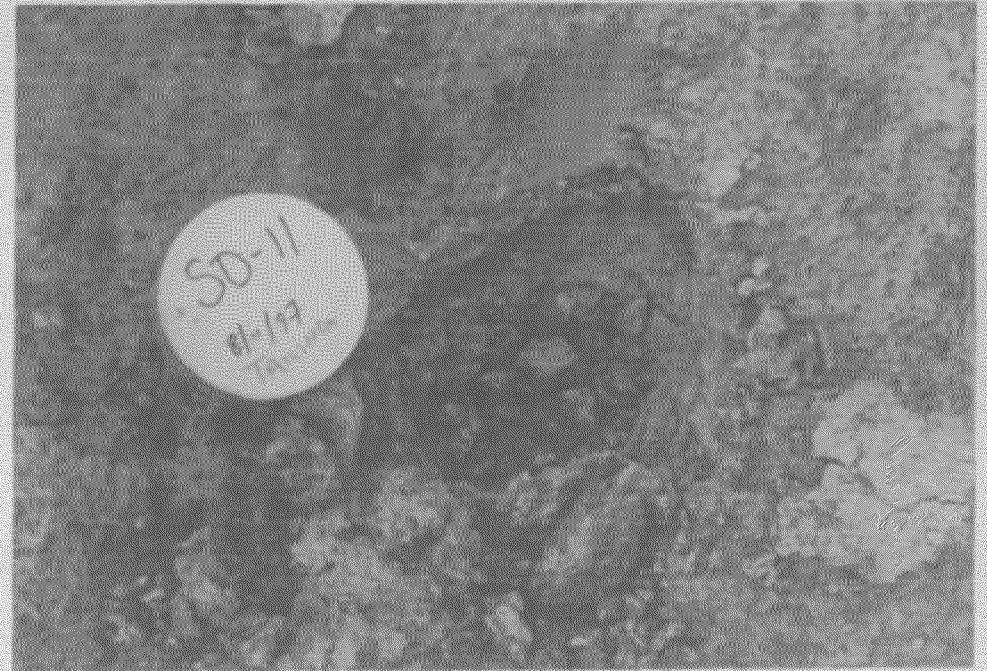
Description of Photo: SO-11 Bagley T. Tailing Pile sample.
Date: August 11, 1997 Time: 1315
Direction facing: East (35mm film)

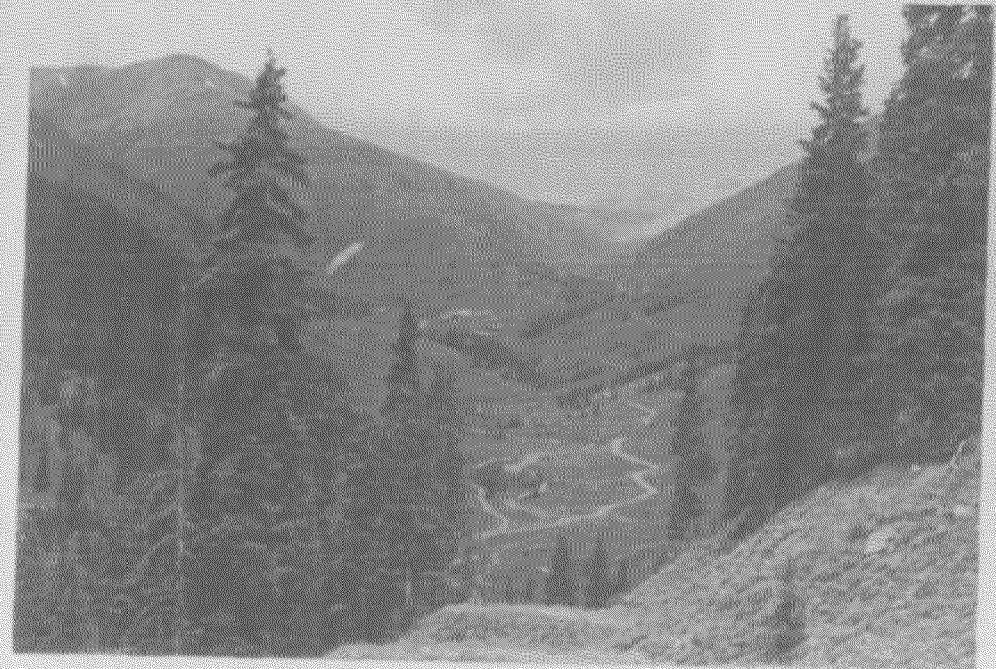
Description of Photo: SO-13 Columbus Mine Waste Pile at Animas Forks.
Date: August 11, 1997 Time: 1315
Direction facing: North (35mm film)

The London Mine, located in Burrows Gulch, and the Columbus Mine located at the terminus of California Gulch, may also be remediated. If required, both the London Portal and 2 adits at the Columbus Mine will be bulkhead sealed to prevent direct mine discharge in order to restore the hydrologic regime to near pre-mining conditions. Construction of upland diversion ditches around, and regrading, neutralizing and revegetating the affiliated mine dumps are also planned (CDPHE, 1997).

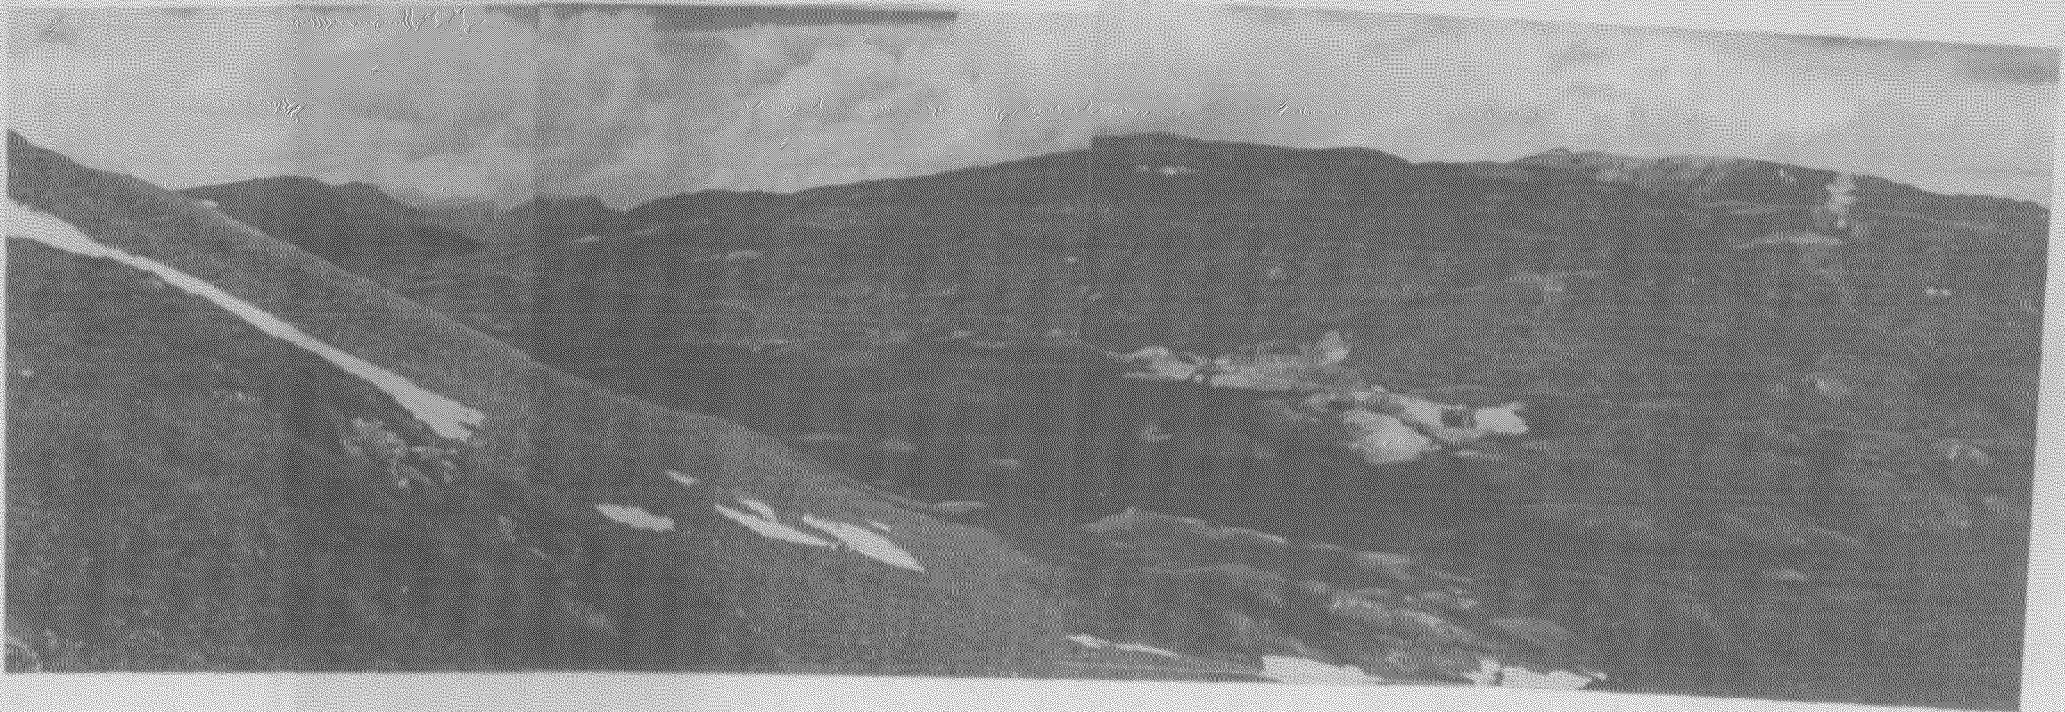
Description of Photo: SO-18 London Mine
Date: August 12, 1997 Time: 1200
Direction facing: North (35mm film)

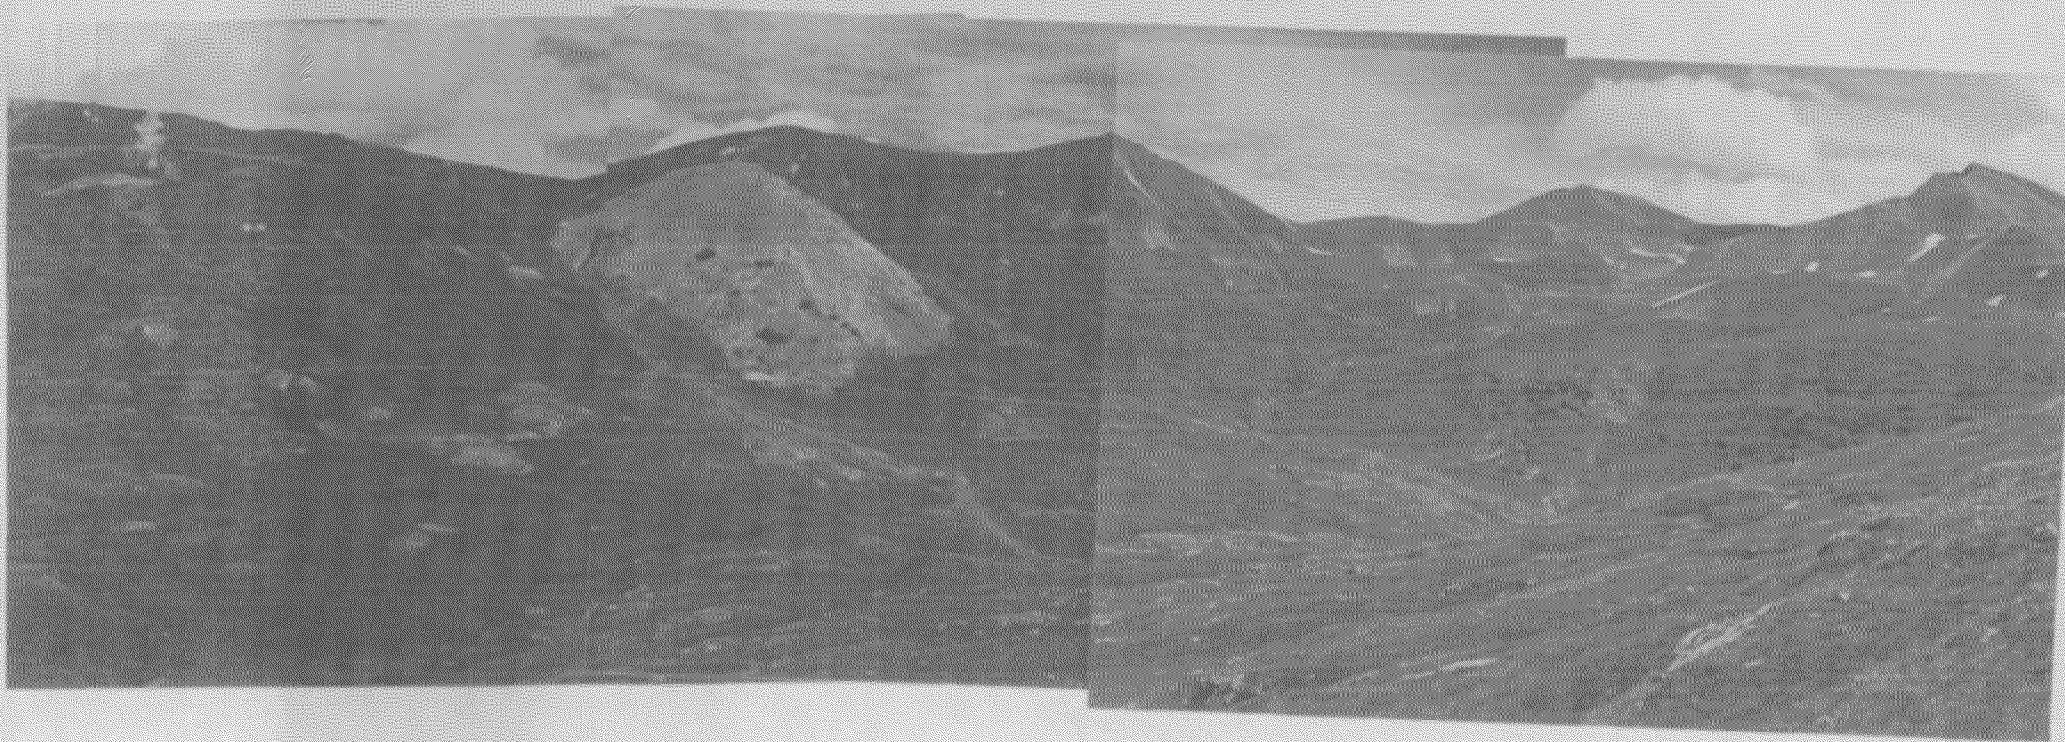
Description of Photo: 60-18 London Mine
Date: August 12, 1997 Time: 1200
Direction facing North (35mm film)

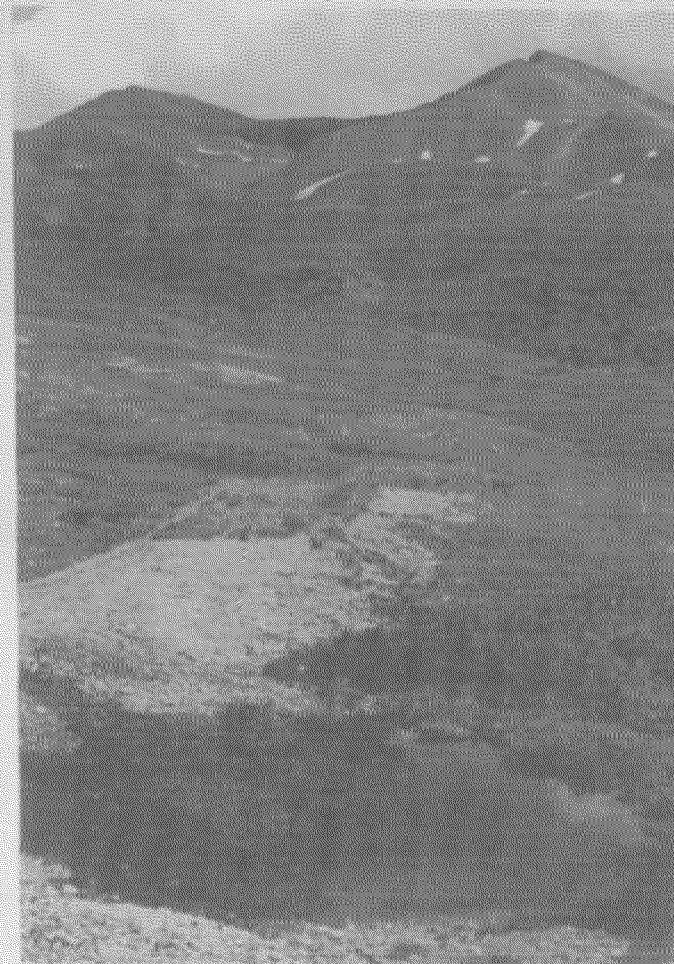
Description of Photo: SO-18 London Mine Waste Pile drainage.
Date: August 12, 1997 Time: 1200
Direction facing: North (35mm film)

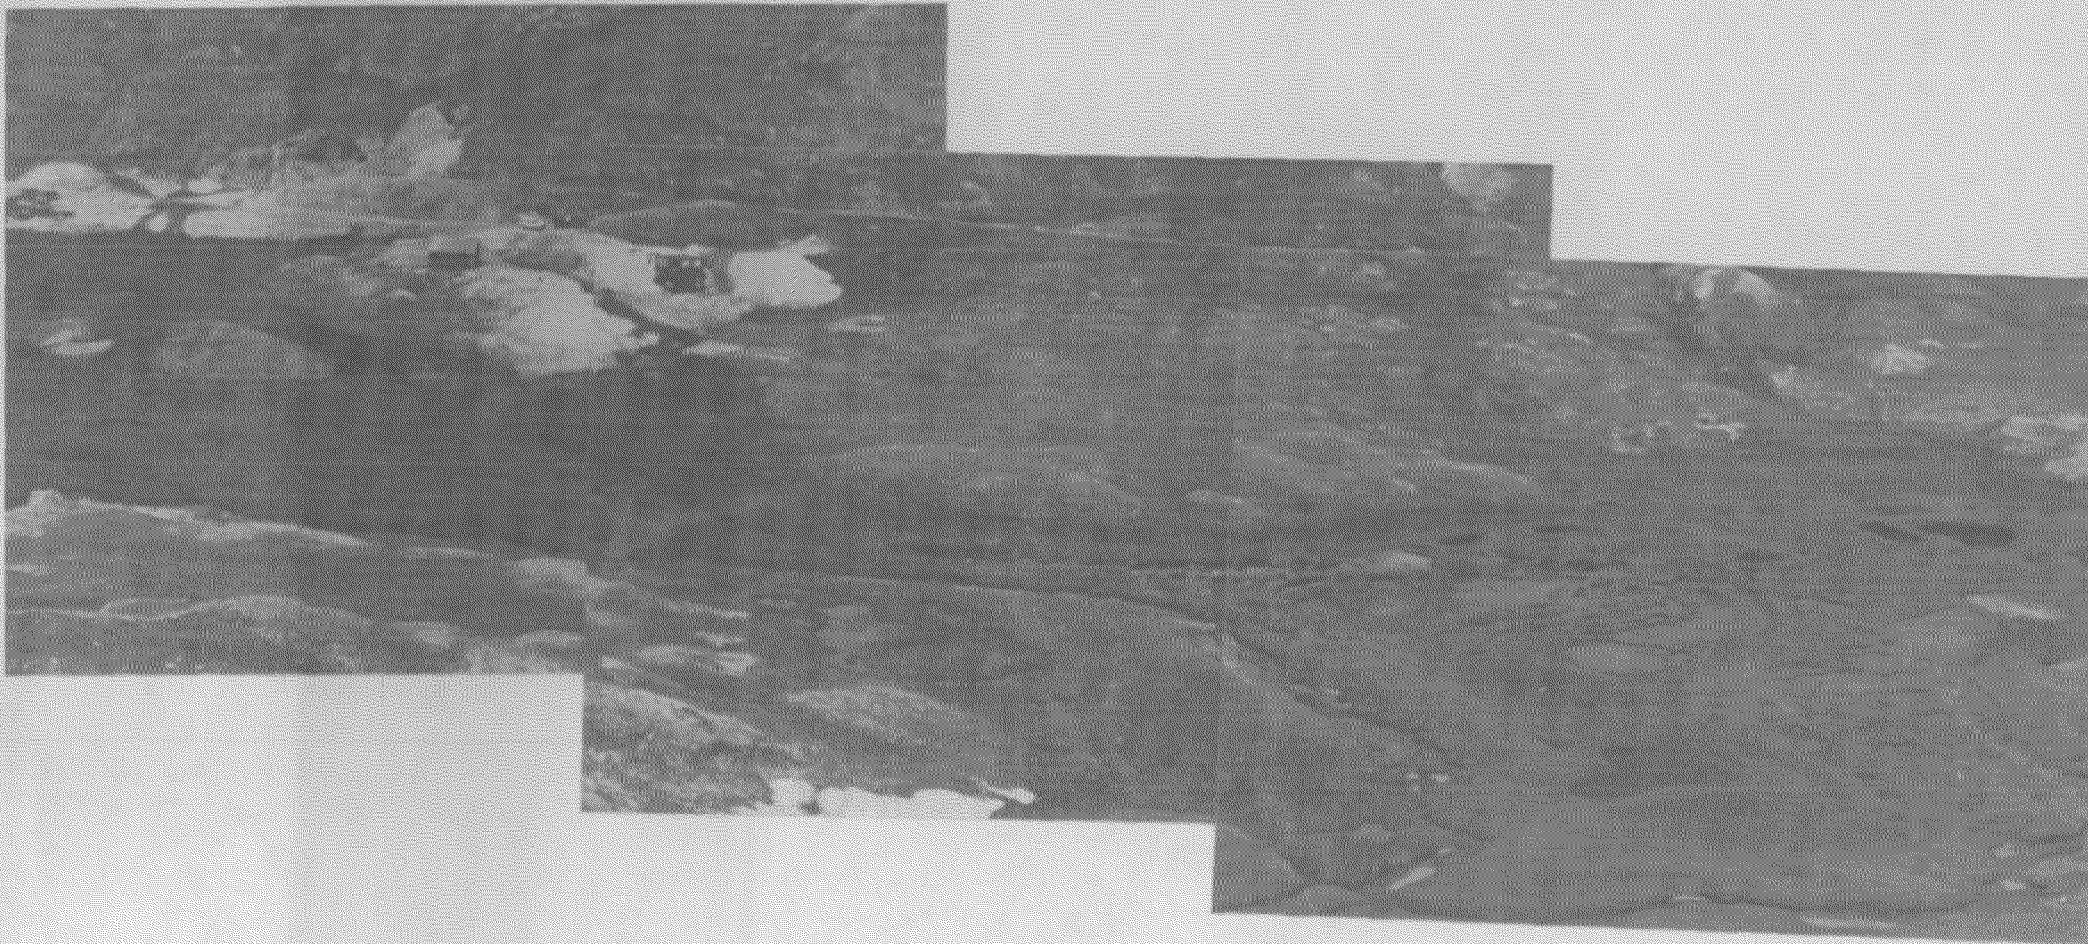
Description of Photo: SO-18 London Mine and wetlands to the east
